Case Report

Gross Trunnion Failure in Total Hip Arthroplasty: A Case Study and Review Article

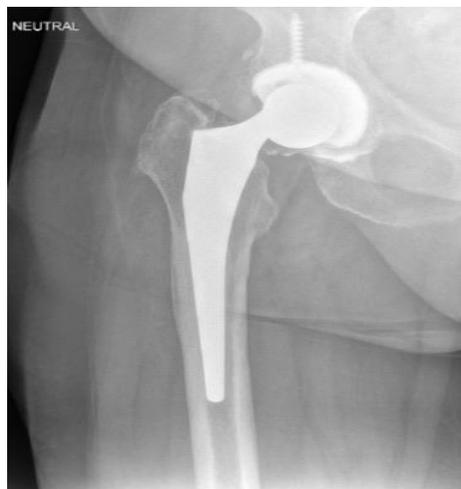
Figure 1: Right total hip arthroplasty with impending GTF demonstrating an oblique angle between the femoral head and the trunnion (narrow arrow); Faint radiodensities can be seen around the hip (three larger arrows).

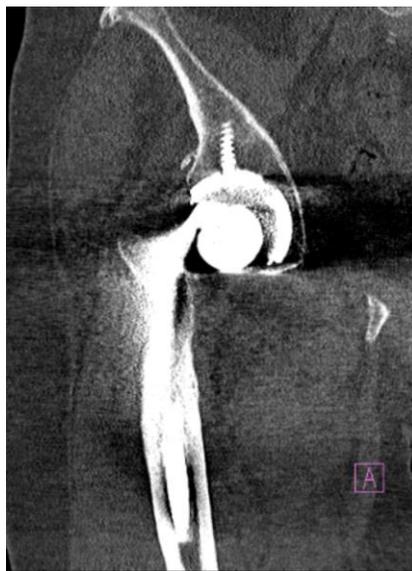
Figure 2: The femoral stem is seen disengaged from the trunnion and is seen between the femoral head and the acetabular rim.

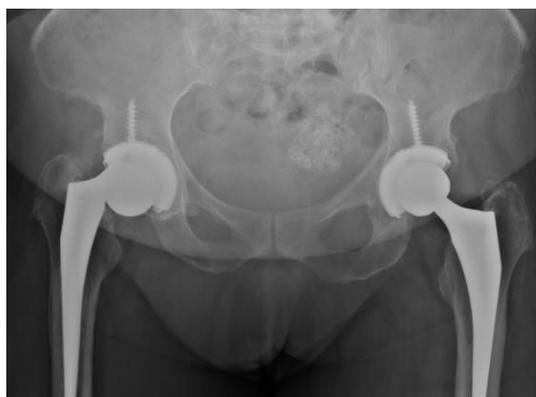
Figure 3: Radiographs demonstrating disengagement of the femoral head from the trunnion.

A revision of the hip was planned in an urgent manner. A posterolateral approach was used. Dark coloured fluid was present once we incised the hip capsule. The synovium was black stained (figure 4). Five intraoperative samples were obtained revealing a negative gram stain. Closed spaced cultures did not grow any anaerobic or aerobic organisms after 5 days. Furthermore, there was no fungal growth after 30 days, direct fluorescent stain was negative for acid fast bacilli, and mycobacterium cultures also showed no

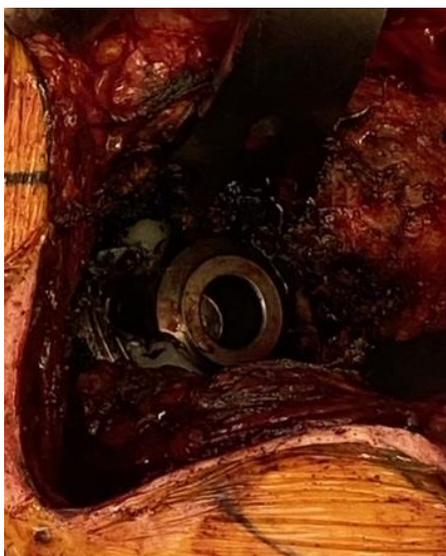
Figure 4: Black discoloration due to metal debris. Arrow demonstrates the worn polyethylene liner and acetabular rim

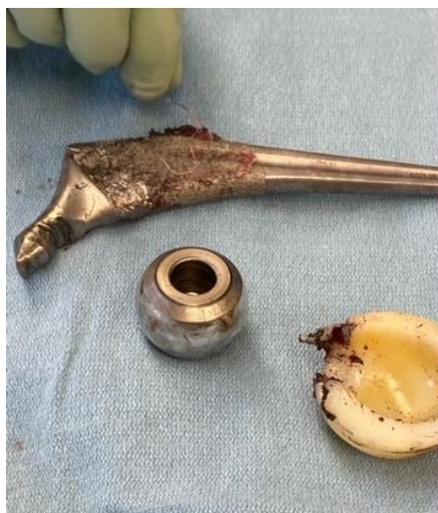
aspect of the acetabular component and the locking mechanism (figure 5), allowing an effortless extraction of the liner. Due to the trunnion damage the femoral stem was successfully removed through an endofemoral approach. The acetabulum was deemed to be ingrown in a satisfactory position. Considering the locking mechanism was disrupted

Figure 5: All the components are extracted and demonstrates the “bird beak” appearance of the trunnion as well as the worn polyethylene liner and black discoloration of the femoral head.

the decision was made to cement a liner in place, taking care to restore the offset and the appropriate anteversion. A femoral stem was cemented in 15 degrees of anteversion. A 36mm diameter ceramic femoral head was carefully impacted.

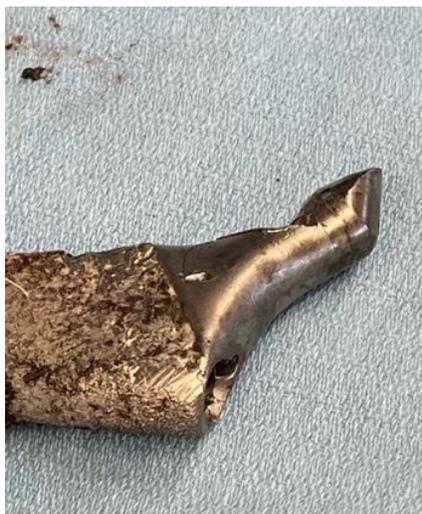
proliferation. Pathology from the synovial tissue demonstrated chronic inflammatory infiltrate with no evidence of aberrant lymphoid population. The lymphoid population consisted of follicular hyperplasia with primary and incipient lymphoid follicles. T-cells were unremarkable and plasma cells were scant and polytypic. Intraoperatively, the femoral head was found to be disengaged from the stem (figure 4), along with gross damage to the femoral trunnion (figure 6). The trunnion also damaged the superolateral

Figure 6: A close view of the “bird beak” appearance of the femoral trunnion.
